Oil & Gas Portfolio

Natural Gas Carbon Steel Flange Replacement

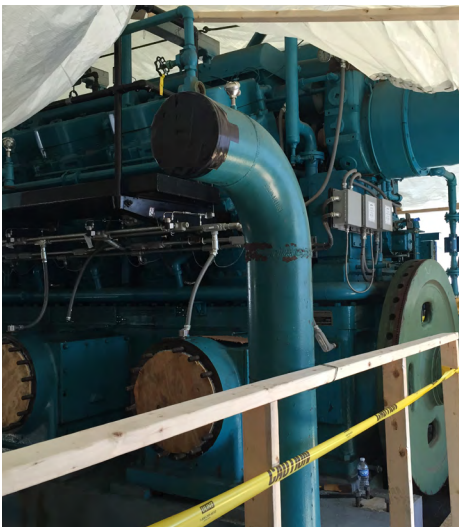
After talking to the client, our team determined that we should install two flanges at the site of the cut-out to facilitate any future maintenance. We ordered two 8" 300# carbon-steel flanges to be shipped to the customer's site. When HPS' weld crew arrived on site, they completed a routine assessment of the work area and immediately made safety improvements. After covering holes in the floor and securing the ladder, the crew began the flange installation.

The crew prepped the welded the joints, and efficiently demobilized. All in perfect time for our third-party nondestructive testing (NDT) expert to x-ray the joints and turn them over to the customer.
