## Industrial Portfolio Overflow Valve Installation

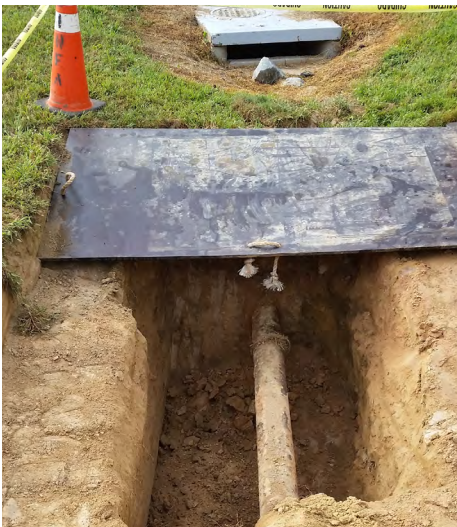
High Purity Systems quickly identified a solution and, in the end, was able to meet specifications while completing installation just a week later. The end result was 4" piping with  $\frac{1}{4}$ " tolerances. Not only did HPS complete the renewed drain piping system, but we also did it swiftly to solve a problem that could have caused major delays for our customer.
